LIMESTONE BRANCH WATERSHED

2005 PROFILE

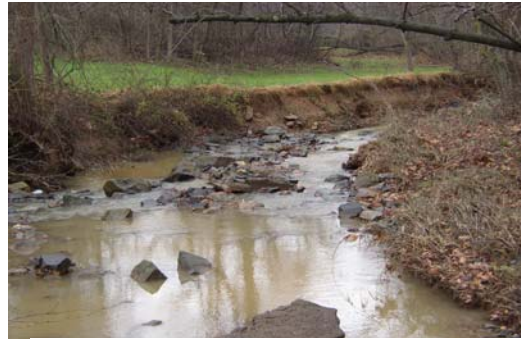
Impervious Surfaces -- Impervious surfaces include the roadways, driveways, rooftops and parking lots that do not allow infiltration of water from rainstorms and runoff. The Loudoun County Environmental Indicators Project (LEIP) includes mapping of impervious surfaces in the county using Lansat Imagery. They report that the amount of impervious surface in the Limestone Branch watershed is less than 1%. As a general rule, a watershed with less than 10% of its area in impervious surfaces will not experience a noticeable impact on the hydrological characteristics of the watershed. However, lawns in residential areas and golf course fairways located in soils with high runoff potential can be an exception to this rule. High flows that cause downstream streambank erosion and flooding are common in portions of the Limestone Branch watershed.

Turbid waters and streambank erosion downstream of residential-golf course development in Limestone Branch watershed

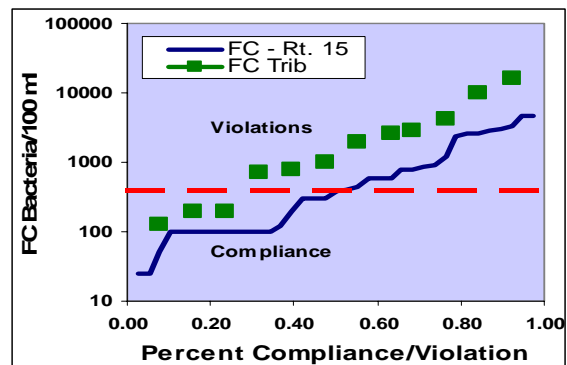
Figure 1. Fecal Coliform Bacteria Levels in Limestone Branch, 1995-2004.

The 1995-2004 DEQ fecal coliform bacteria data, plotted as cumulative percentages to show the percent of samples that exceed the standard, are provided in **Figure 1**. The water quality at the Rt. 15 station does not meet state standards in that about 50 % of the samples are above 400 fecal coliform. MapTech also collected fecal coliform data at a station on the unnamed tributary at Rt. 661. Seventy-five percent of the samples at this station exceeded the state standard, as well. These data are also shown on **Figure 1**.

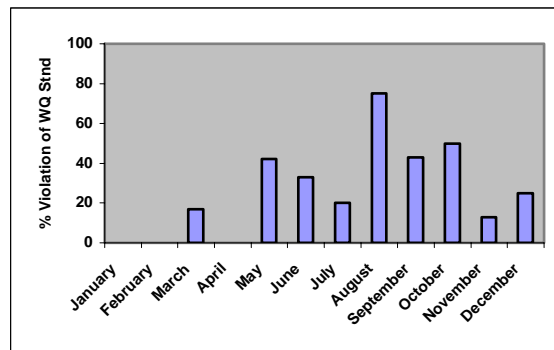
Figure 2. Seasonal Distribution of Violations of the 1998 Fecal Coliform Standard in Limestone Branch at Rt. 15.

DEQ also analyzed the water quality data to determine whether there is a seasonal pattern in violations. These results are shown in **Figure 2**. The violation rate is highest from May to October when water flow is likely lowest and livestock have the greatest access to streams.

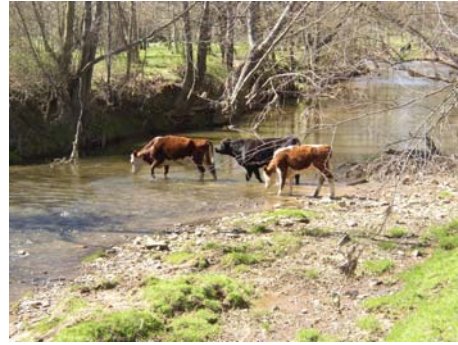
- **Livestock** – DEQ used 1997 agriculture date for Loudoun County to estimate the number of livestock. The Limestone Branch watershed contains approximately 3% of the total pastureland in the county. Wastes from livestock are deposited directly to the stream where livestock have stream access, and are deposited on the land where it is available for transport to streams in surface runoff. DEQ estimates there are approximately 1,200 cows, cattle and calves; and 100 horses in the watershed.

Livestock with stream access deposit wastes and erode stream banks.

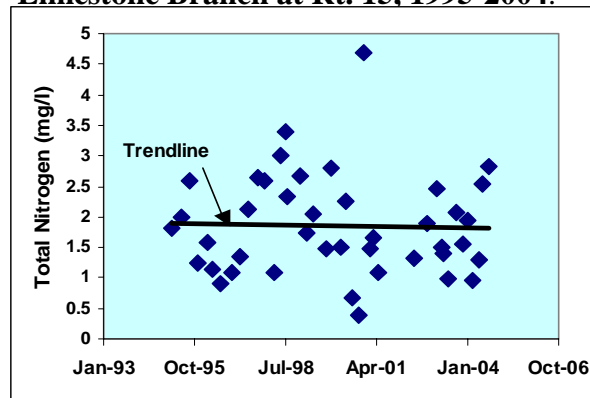
Figure 3. Total Nitrogen Levels for Limestone Branch at Rt. 15, 1995-2004.

Chesapeake Bay Nutrient Reduction Goals -- Government and citizen groups in the Chesapeake Bay watershed have working since 1987 to reduce the amount of nutrients flowing into the Bay from tributaries such as the Potomac River and its tributaries including Limestone Branch. An analysis of DEQ's nitrogen data for 1995-2004 is provided in **Figure 3**. The trendline for these data show that nitrogen levels are not being reduced over this time period. It is critical to reduce nitrogen in order to raise the dissolved oxygen levels in Chesapeake Bay and eliminating the "dead zones" in the Bay where the lack of oxygen is killing fish, crabs, and shellfish.

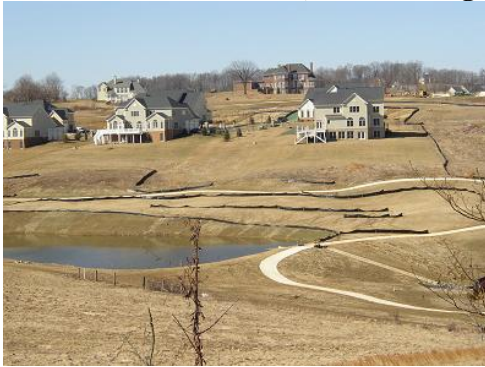
Mowed grass and hilly terrain results in high stormwater runoff flows, downstream erosion, and flooding.

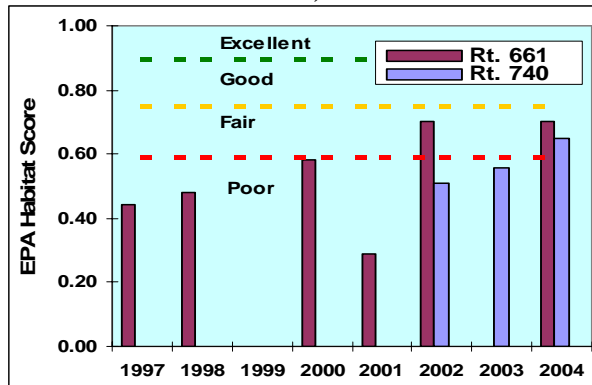
Figure 4. Stream Habitat Condition on Tributaries to Limestone Branch at Rt. 661 and Rt. 740, 1997-2004.

Loudoun Wildlife Conservancy – LWC has collected stream habitat data at two sites on tributaries in the watershed using the EPA RBPII protocol for several years. Monitoring at the Rt. 661 site was started in 1997, and monitoring at the Rt. 740 site started in 2001. The quality of the stream habitat is assessed using ten parameters that are combine into a "habitat condition score." The results are summarized in **Figure 4**.

These data show that the stream habitat condition is generally in the "poor" to "fair" range of conditions. This indicates that the streamside habitat is being degraded by human activities, and that the health of aquatic life can be impacted. The greatest problems are loss of riparian buffers and natural vegetation that stabilizes the streambank and help prevent erosion. As a result aquatic insects that live in the cobble and gravel in the stream substrate are smothered by sediments from erosion, and from shifting substrates caused by high stormwater flows.

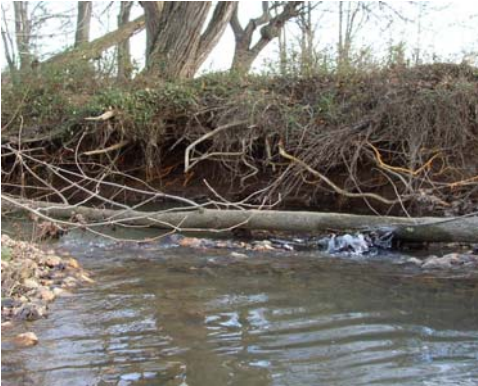
Steep banks with active erosion and undercutting of trees from high flows along Rt. 740.

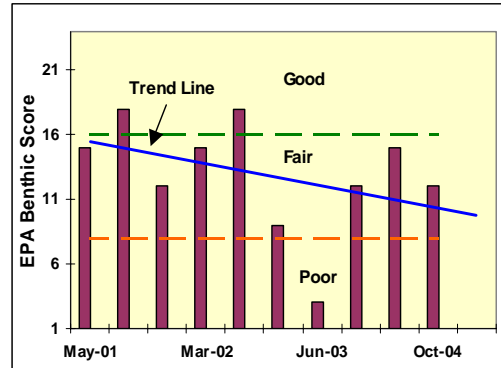
Figure 5. Aquatic Life Conditions in Tributary of Limestone Branch at Rt. Rt. 740, 1997-2004.

The results for the station off of Rt. 740, Tutt Lane, are shown in **Figure 5**. They indicate the conditions of the aquatic insect communities at this monitoring site are generally in “fair” range. There are a reduced number of different types of insects, fewer insects that are intolerant to pollution and sediments, and more insects, such as black flies, that are tolerant of pollution. The data also show that conditions are getting worse. This site is downstream of a large development that includes a golf course. There are few natural riparian buffers and high levels of runoff from the steep slopes on the golf course that contribute to streambank erosion problems downstream.

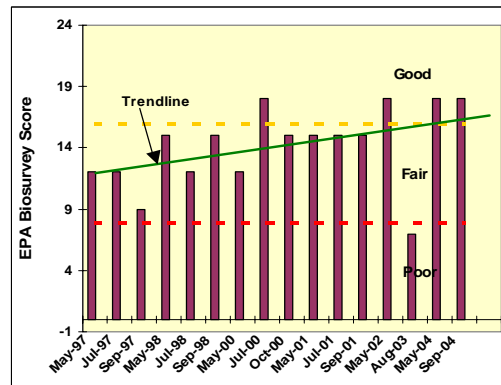
Figure 6. Aquatic Life Conditions in Unnamed Tributary to Limestone Branch at Rt. 661, 1997-2004.

Aquatic life conditions in the other tributary at the Rt. 661 station where there is no large development and golf course in the headwaters are different as seen in **Figure 6**. The conditions are generally in the “fair” to “good” range that means there are greater species diversity, more insects intolerant to pollution and sediments, and fewer that are pollution tolerant. Conditions also seem to be improving as shown by the trendline. This monitoring site is downstream of a regional park, and park authorities have fenced off the stream from livestock, planted trees, and allowed the natural vegetation to grow in the riparian buffer. This is greatly improving the stream habitat and stream conditions upstream of the monitoring site, and it may account for the improving aquatic life conditions at the downstream site.
