# **Loudoun County Planning Commission**

## **Water Quality/Stream Briefing**

**December 12, 2012**

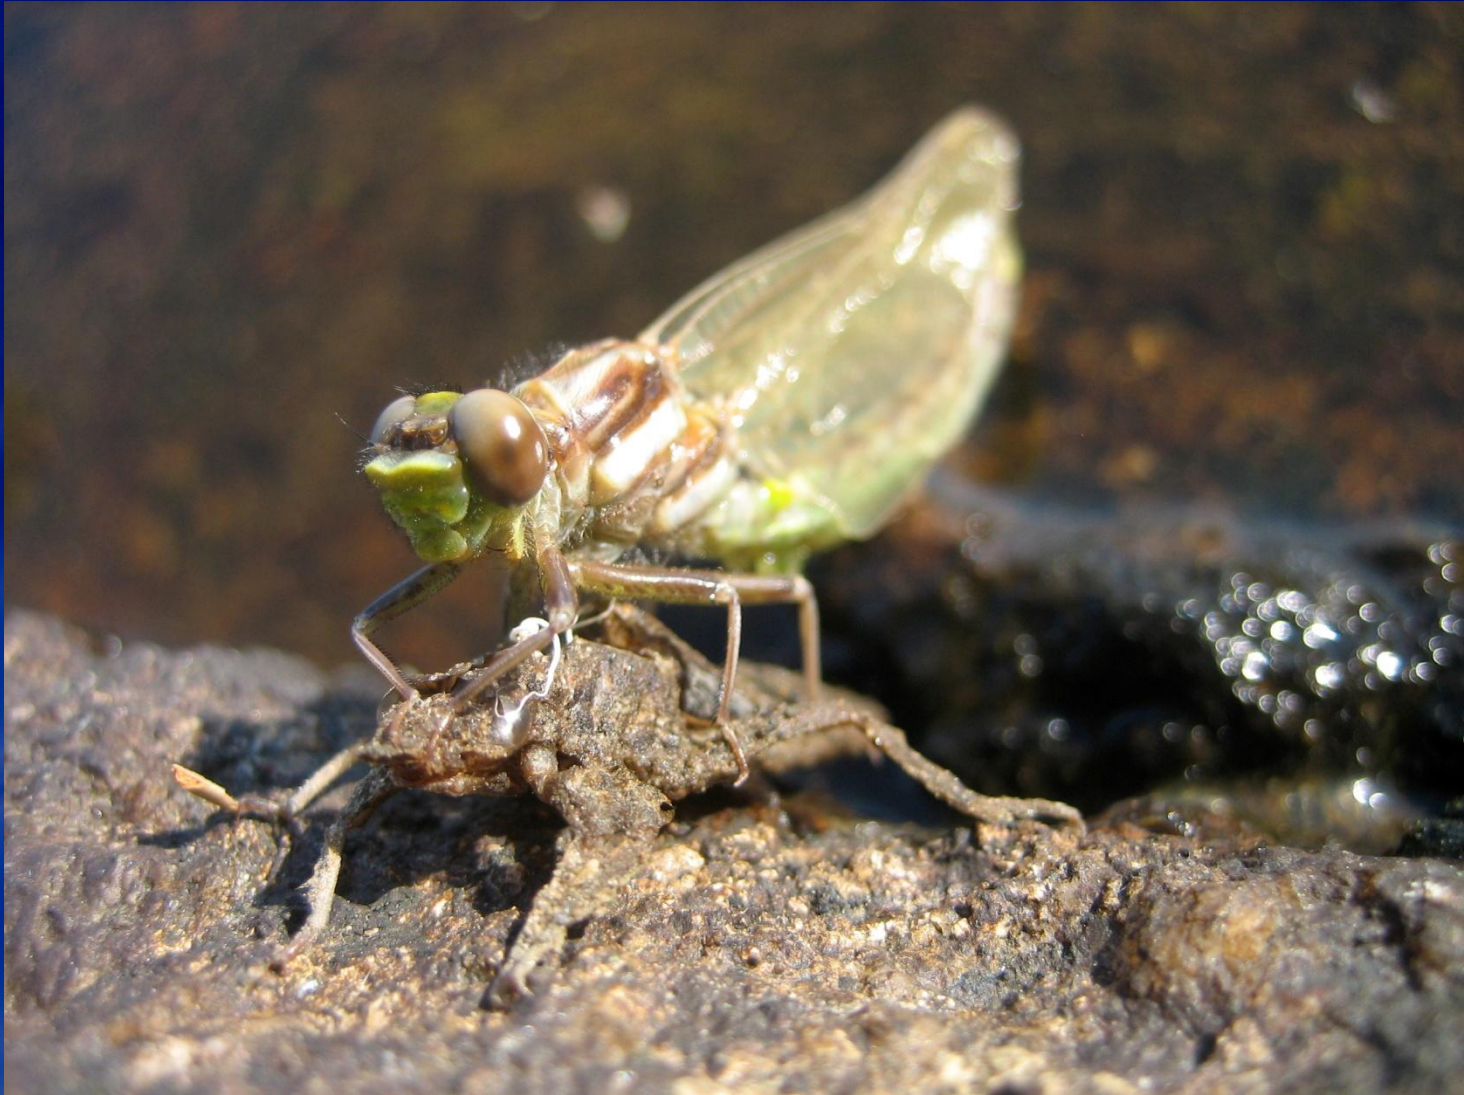
# A Dragonfly Emerges

- The female dragonfly lays her eggs on a plant near the water or drops them in the water.
- Most of a dragonfly's life (up to 4 years) is spent as a nymph in the water. During this time, one of the main food sources for the nymph is mosquito larvae.
- The nymph leaves the water, crawls out of its larval skin, and begins to fly.
- The adult stage only lasts between 2-4 months.

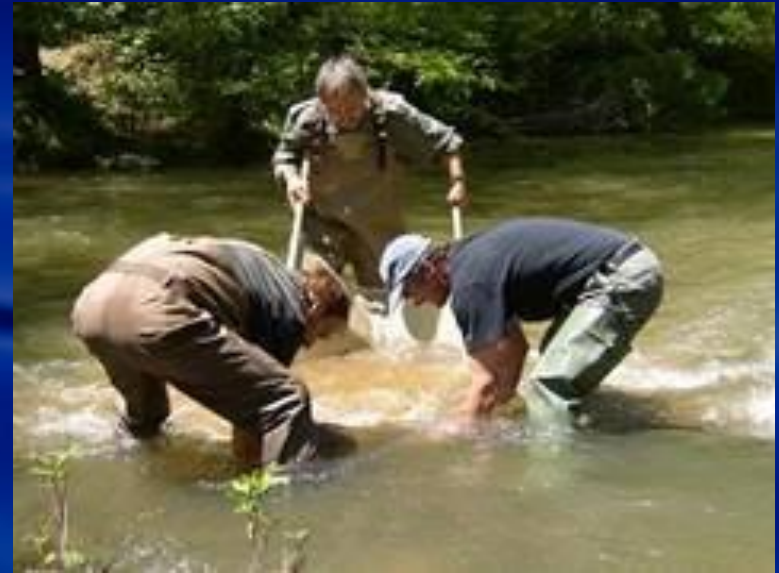
- If biological sampling results in a score of less than 42 out of a possible 100, the stream is considered severely stressed. A stream scoring between 43 and 59 is considered stressed. Both severely stressed and stressed streams are categorized as being impaired for aquatic life (9 VAC 25-260-10 A).
- DEQ has identified sediment, nutrients, and habitat modification as three of the primary sources of stream degradation.

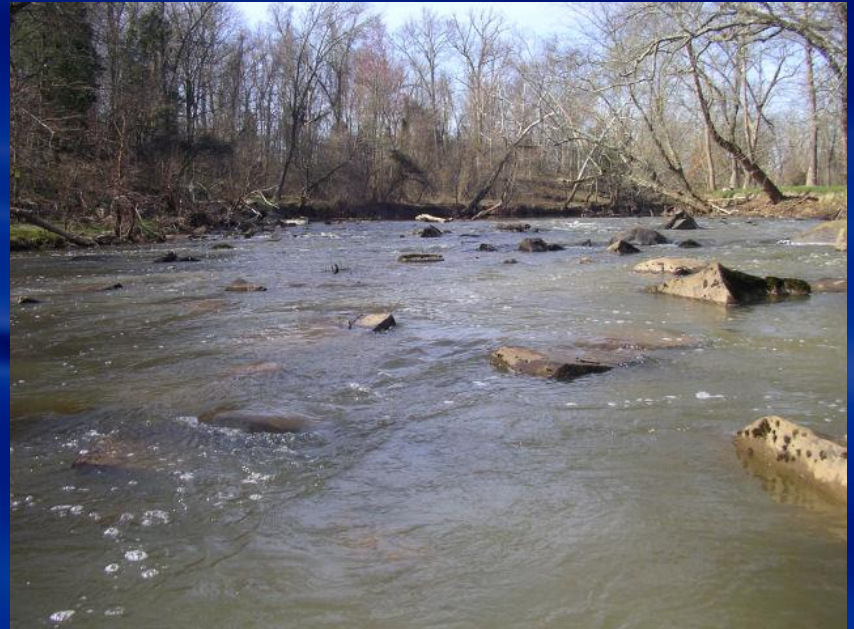
# Water Quality Data

- Drain to a segment of Broad Run that is impaired for aquatic life (VAN-A09R-BRB01A00 & VAN-A09R - BR02A06).
- Segment begins at the confluence with Cabin Branch and continues downstream to the confluence with the Potomac River.
- First listed in 2006. TMDL scheduled for 2018.
- County's 2009 Stream Assessment – “suboptimal” for habitat and “severely stressed” for aquatic life.

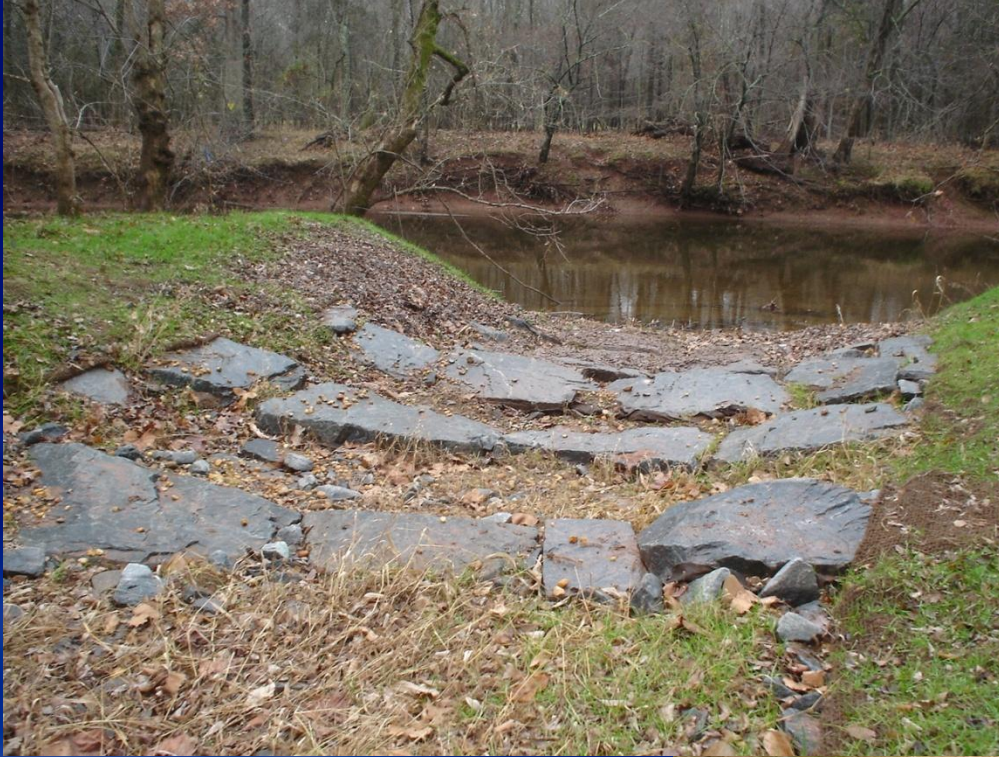
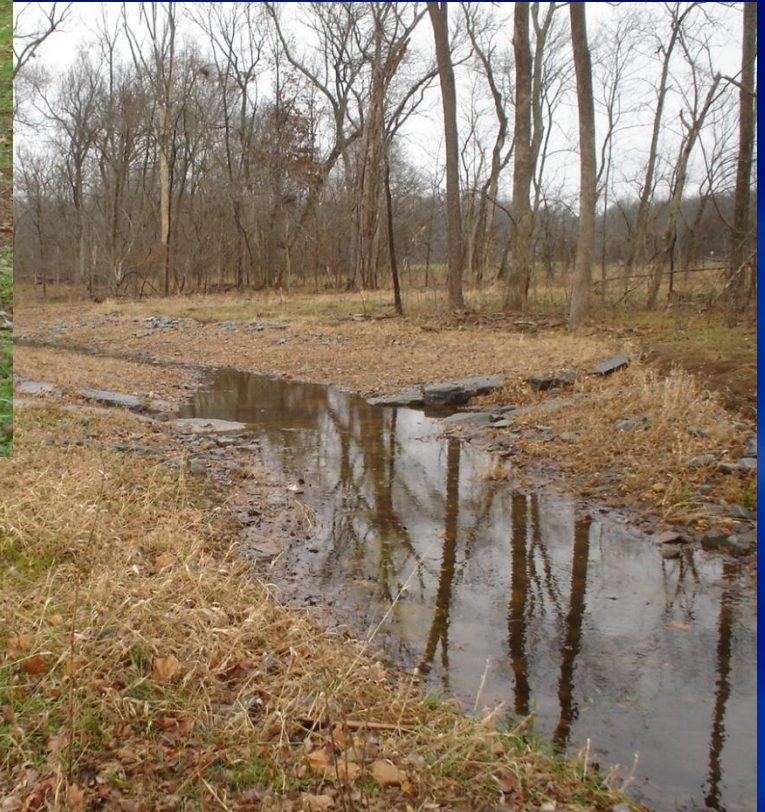
# Kincora Stream Enhancement

- Drains to downstream segment of Broad Run that is impaired for aquatic life.
- \$1,889,000 of bonded environmental improvements have been installed, including:
  - 2,425 linear feet of stream enhancement,
  - 2.5 acres of on-site wetland mitigation,
  - an 8.6-acre wetland mitigation bank,
  - 56 acres of riparian reforestation,
  - 3 acres of reforestation to offset river and stream corridor resource encroachments.
- The project also preserves 69 acres of riparian forest cover and 3 acres of upland forest cover.
