Subject: Citizen Nomination for Stream Monitoring

Loudoun Wildlife Conservancy and Loudoun Watershed Watch are pleased to provide several nominations for additional stream monitoring locations to be considered for inclusion in DEQ's Water Quality Monitoring plan for calendar year 2026. This year we met virtually as a committee and selected 5 candidate sites. We used a comprehensive interactive map with stream monitoring data and stream impairments, past stream monitoring nominations, and past DEQ stream monitoring plans.

Site 1: Beaverdam Run - SW site area

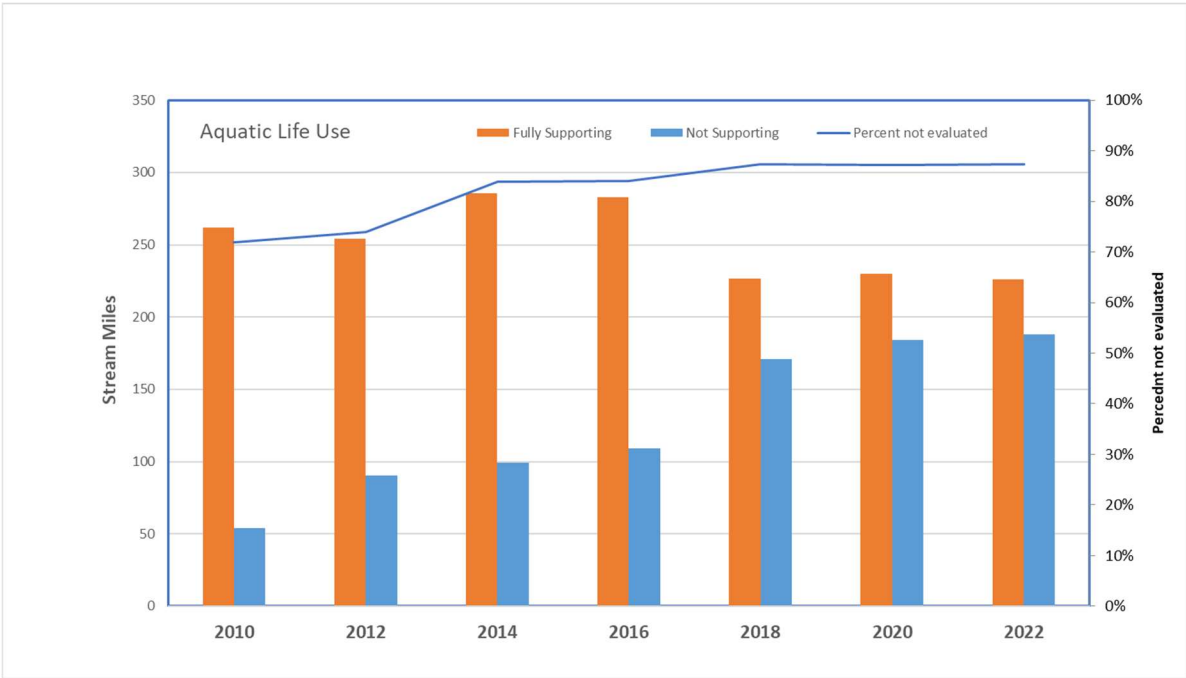
We understand that only a limited percentage of the stream miles in Loudoun County have been assessed for aquatic life use through benthic monitoring of the macroinvertebrate community in the streams. The percentage

changed from 30% to about 13% when DEQ changed to a higher density of streams. We understand that VA DEQ began stream monitoring in Loudoun County in 1994.

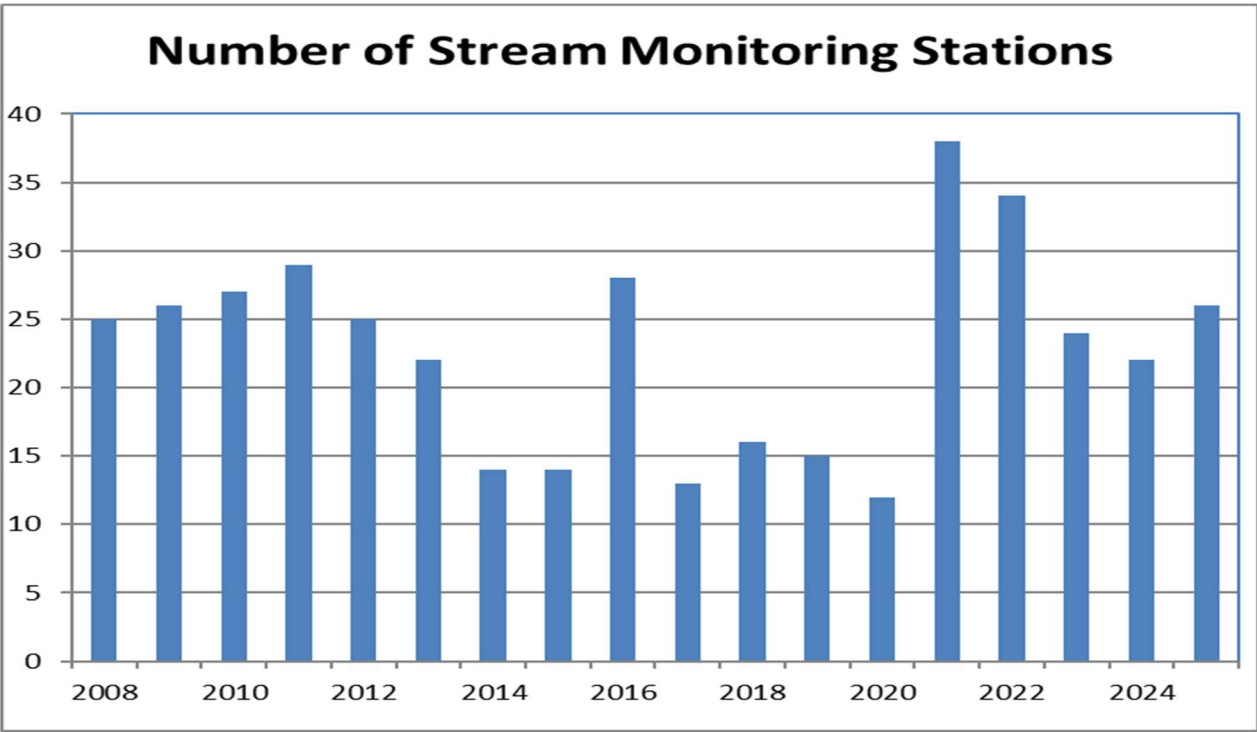
Over the years the number of sites in Loudoun and contributing subwatersheds has varied in which a site is typically monitored in both the spring and fall as VA DEQ requires that two benthic sampling be conducted to be included in the water quality assessment as shown in this chart.

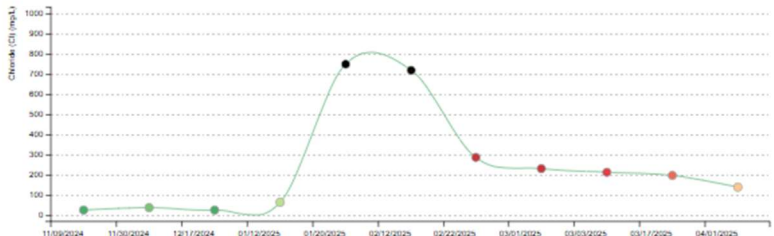
BEARUN4.14

Chloride (Cl⁻) (mg/L)

Date	Chloride (Cl ⁻) (mg/L)
11/09/2024	20
11/30/2024	40
12/17/2024	30
01/12/2025	70
01/29/2025	750
02/12/2025	720
02/22/2025	280
03/01/2025	240
03/03/2025	220
03/17/2025	200
04/01/2025	150

The salt data establish that nearly all reaches are “hit” with a large “dose” of elevated chloride concentrations from winter road salt which is washed down stormwater drainage to the streams.

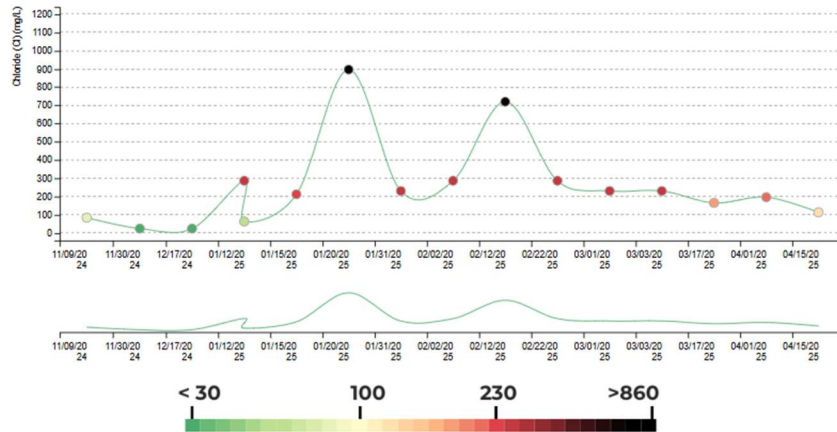
UTBEARUN0.61

Parking at 4300 Marshfield Dr. Take a trail to the stream before it goes in the culvert under the street. Upstream of Claiborne Pkwy.

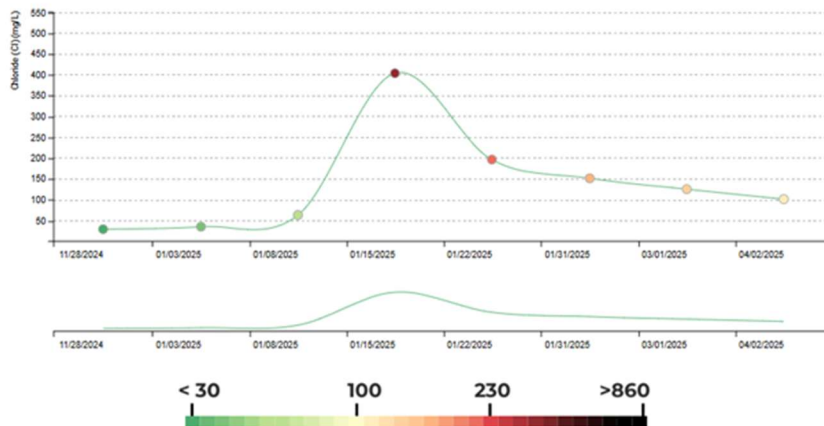
UTBEARUN0.44

Upstream of Hay Road, in between Wildbrook Ct and Wild Meadow Ct

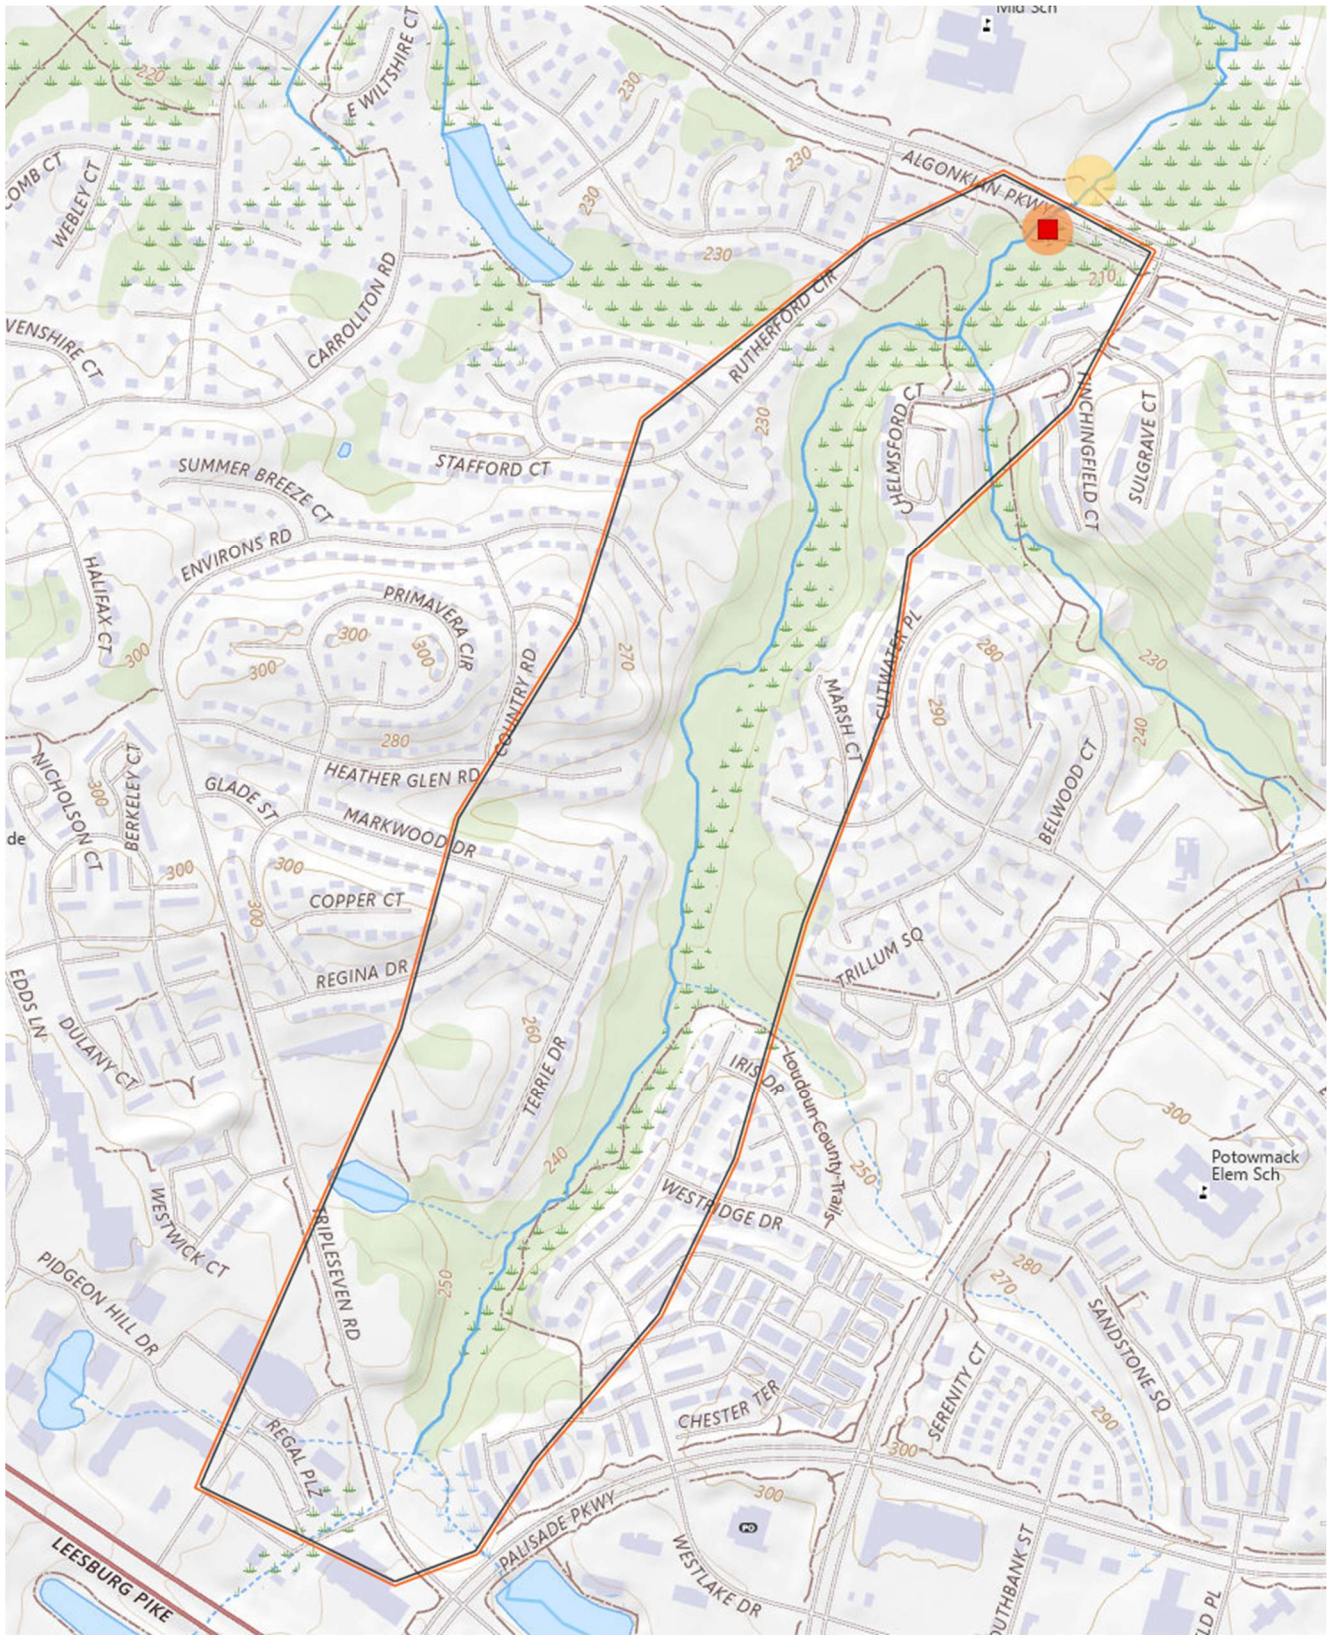
(2) Site maps

Unnamed Tributary - Horsepen Run - Upstream

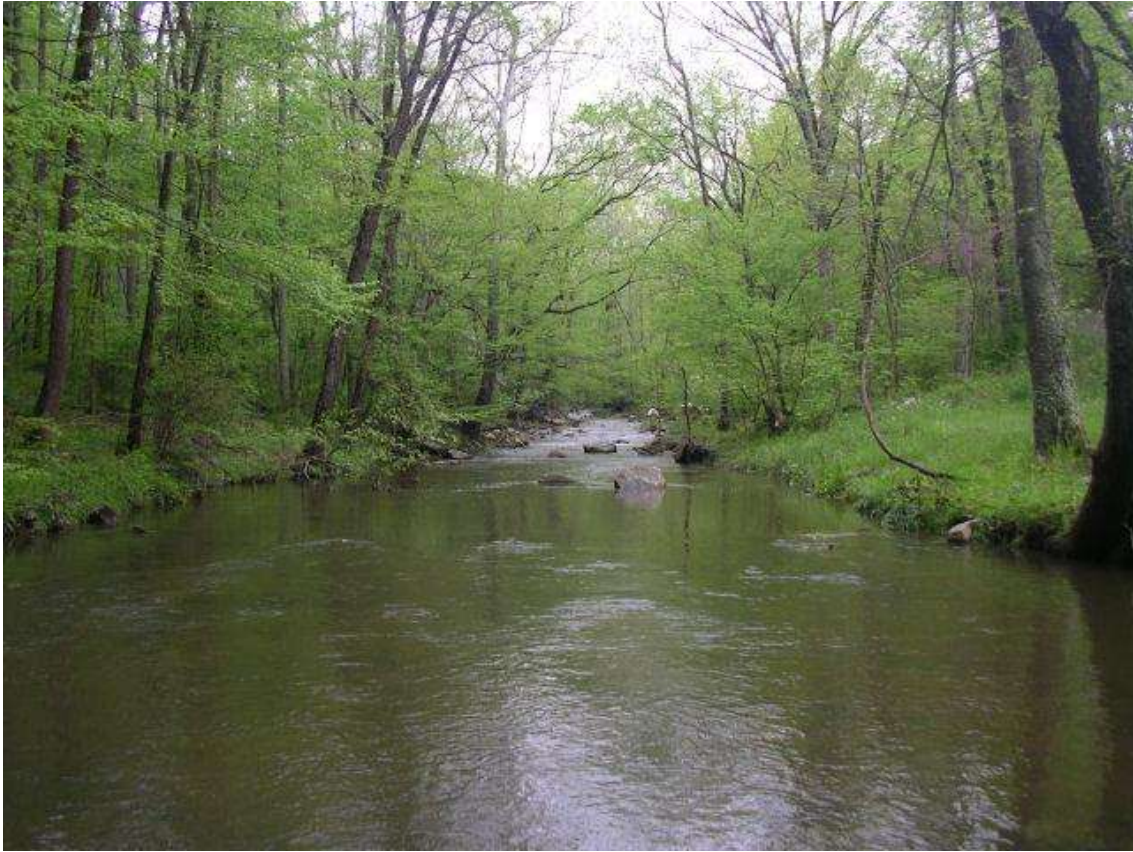
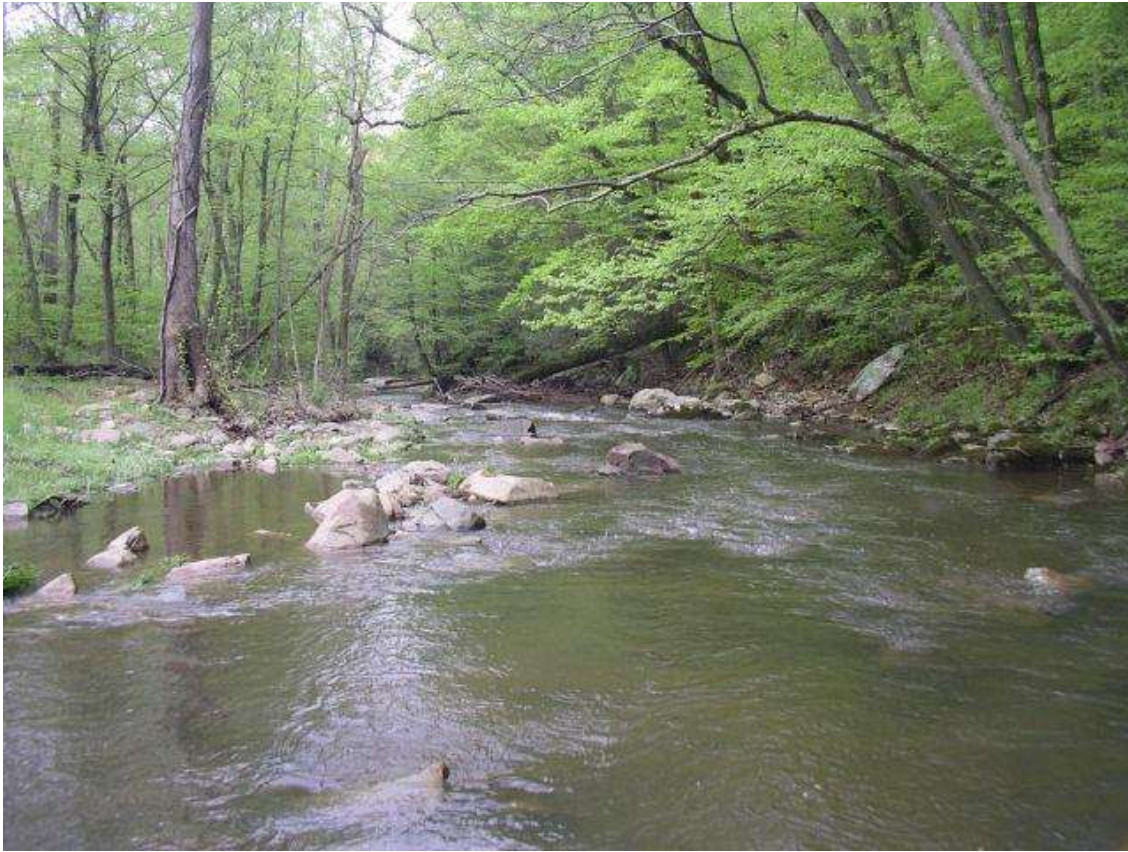
Loudoun County 2009 Habitat: DUTC-301-R-2009

The 2009 data downstream indicated Stress and Optimal conditions.

SiteName	DUTC-301-R-2009
WShed_Code	DUTC
Year_Samp	2009
VSCI	46.45
Assmt_Cate	Stress

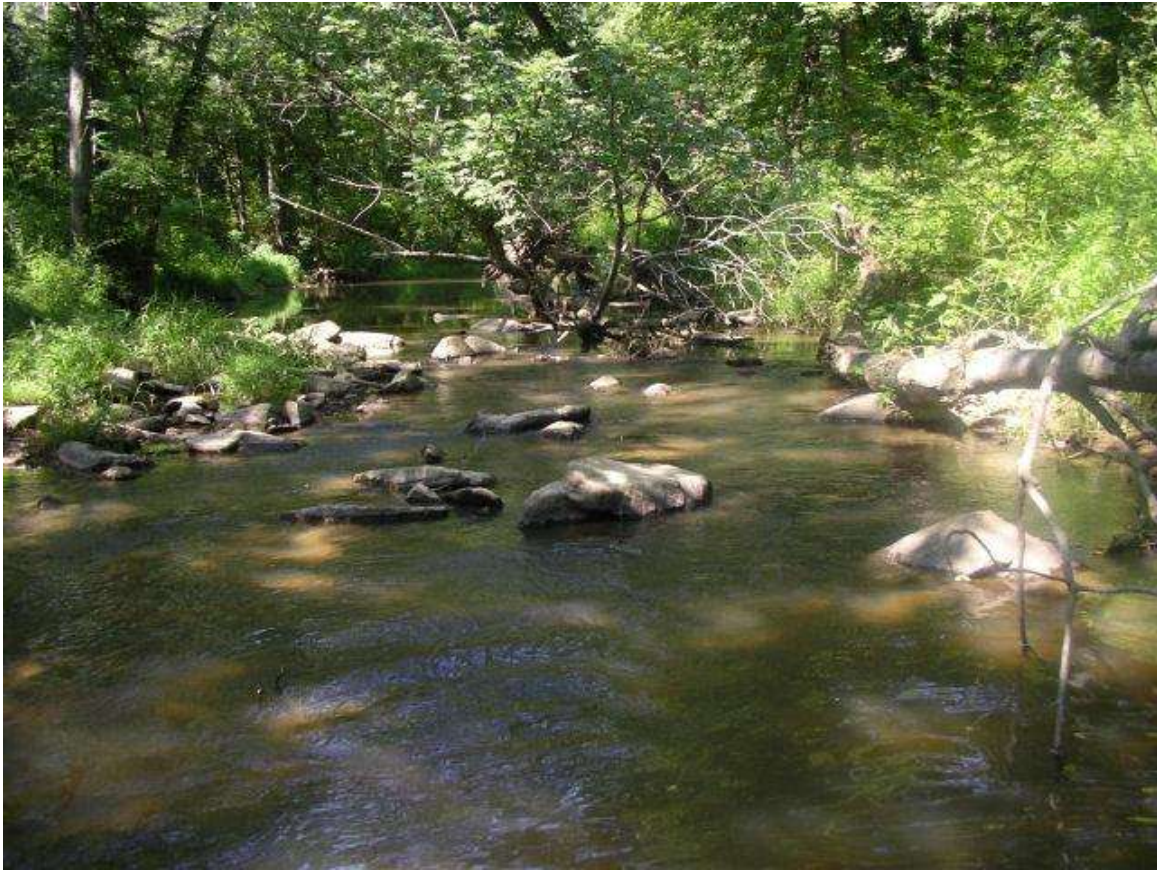
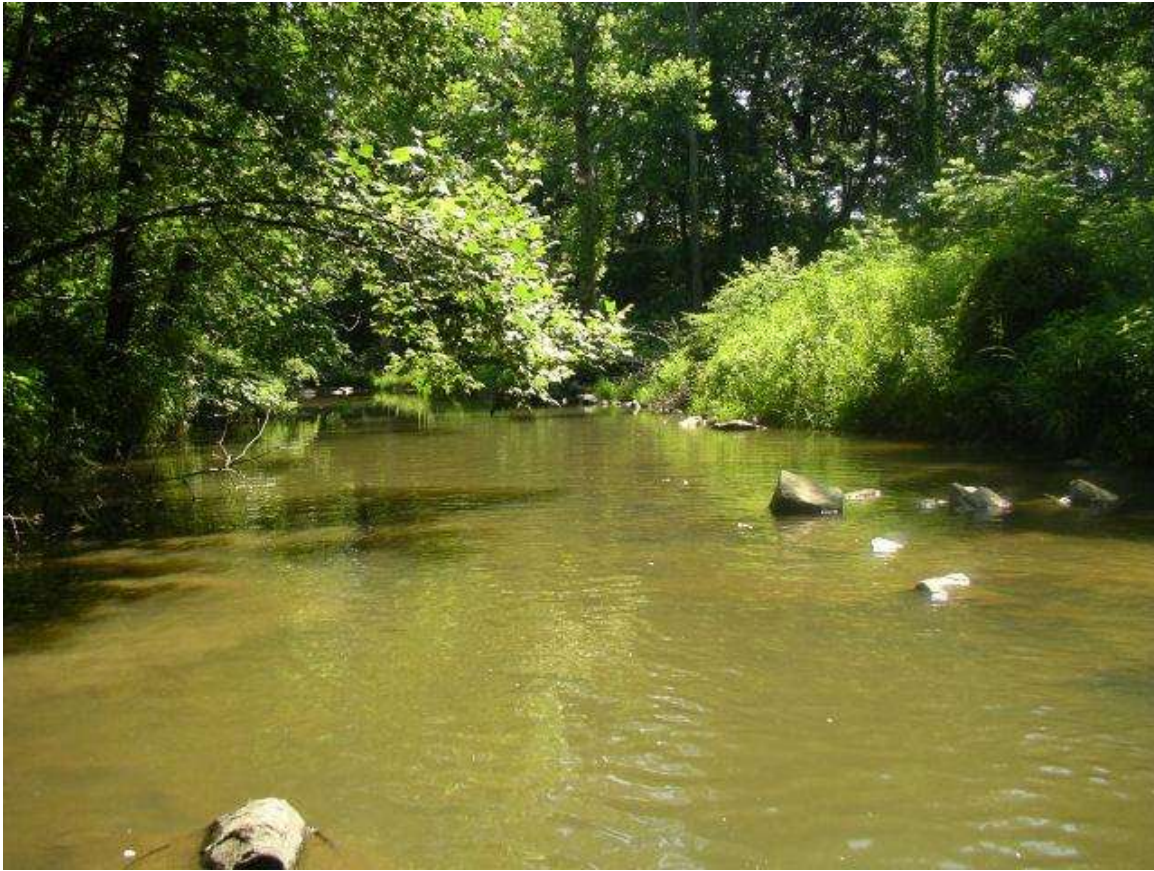
The 2009 data upstream indicated Optimal conditions.

HabSampSna	0.00
HabSampVeg	0.00
HUC12	020700080202
Index_Num	2.00
LU_Com	0
LU_Crop	0
LU_Forest	1
LU_Golf	0
LU_Landfil	0
LU_OldFiel	0
LU_Orch	0
LU_Pasture	0
LU_Res	1
LU_SurMine	0
LU_Wetland	0
Muskrats	0
ndReviewer	TH
NoAbleSamp	
NOper_Snai	0
Oper_Snail	0
Other	
OtherNum	0
Periphyton	1
ph	7.41
ProblemNot	N
PSU_Number	2.00
RBP_Rating	Optimal
RecRain	Clear
RiffleQual
