NORTH FORK GOOSE CREEK WATERSHED 2005 PROFILE

Watershed Description

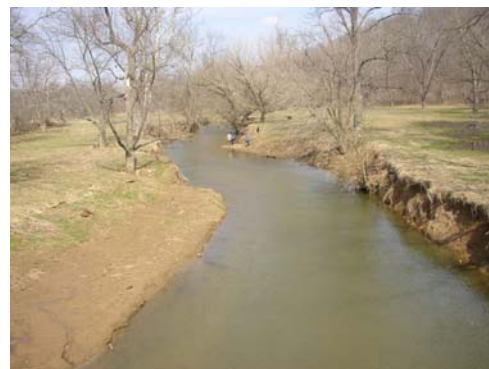
North Fork Goose Creek at Rt. 729 showing affects of use as pasture land.

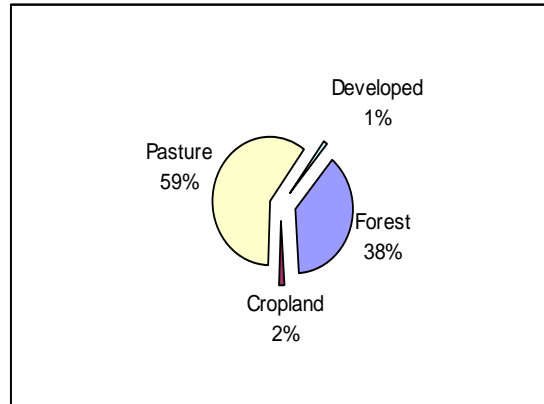
Figure 1. Land Use in North Fork Goose Creek Watershed Based on 1997 Data.

Land Use -- Land use is predominately agricultural and forested lots. There are residential and commercial areas in the towns of Hamilton, Purcellville, and Round Hill. **Figure 1** shows the land-use patterns based on 1997 data published by EPA and provided in DEQ's 2002 TMDL report. The impact of land use on stream quality is seen in the following pictures.

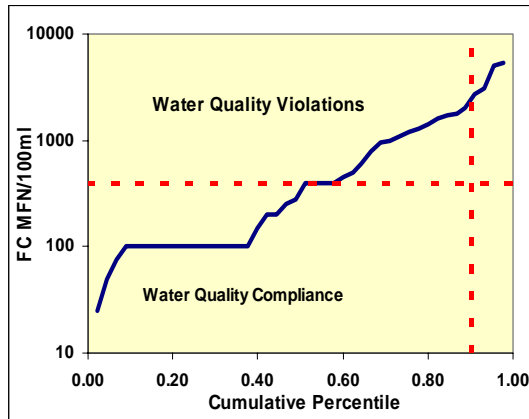
Figure 2. DEQ Fecal Coliform Bacteria Levels for North Fork Goose Creek at Rt. 722 from 1996-2004.

Water Quality Violations – Stream waters that are suitable for recreational use must have low levels of fecal contamination. DEQ has monitored one station in the North Fork watershed for fecal coliform bacteria since the 1970's. The 1996-2004 fecal coliform bacteria data, plotted as cumulative percentages to show the level at which the water quality standard is exceeded, are shown in **Figure 2**.

The water quality at this station does not meet the state standard of 400 fecal coliform approximately 40 % of the time. As a result DEQ has designated 4.29 miles of the stream as impaired or unsuitable for recreational use. In 2003 DEQ began analyzing the water samples to enumerate *E. coli* bacteria – a type of fecal coliform bacteria more directly associated with human disease. An analysis of these data show a good correlation between the fecal coliform bacteria counts and the *E. coli* bacteria counts. Both sets of data have a median of 400 cfu/100 ml, and ranges between 25 and 2000 cfu/100 ml for the fecal coliform and 20 and 1800 cfu/100 ml for the *E. coli* bacteria.

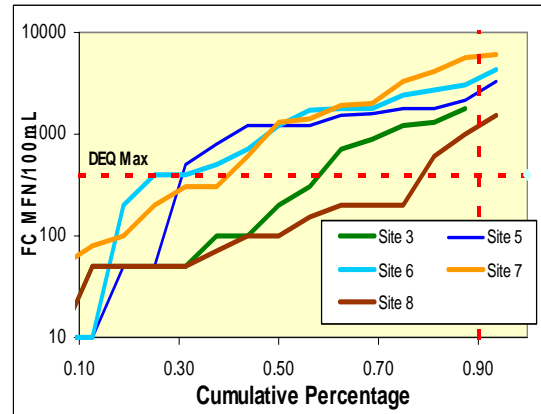
Figure 3. LSWCD Fecal Coliform Data for N.F. Goose Creek Watershed 1999-2003.

Loudoun Soil and Water Conservation District –LSWCD has also collected fecal coliform data at five sites spread throughout the watershed since 1999. **Figure 3** shows that 40% to 70% of the samples at these sites exceed the water quality standard of 400 cfu/100 ml. This indicates that poor water quality conditions are widespread in the North Fork Goose Creek and its tributaries.

Future Impairments? – LSWCD fecal coliform monitoring at three stations in unimpaired segments downstream and upstream of the impaired segment in the North Fork Goose Creek, and in Crooked Run show there are poor water quality conditions similar to those in the impaired segment. The following additional stream segments should be classified by DEQ as having observed affects for fecal coliform:

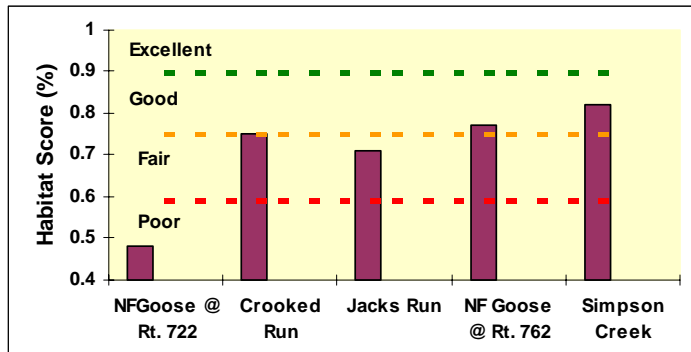
Figure 4. LWC Stream Habitat Scores for North Fork Goose Creek Watershed – 2004.

Loudoun Wildlife Conservancy – LWC has collected stream habitat data at six sites in the watershed using the EPA RBP II protocol since 1997. The quality of the stream habitat is assessed using ten parameters that are combine into a “habitat condition score.” The results are summarized in **Figure 4**. These data show that stream habitat conditions range from poor to good. This indicates there has been a moderate loss of natural habitat, and that habitat in some portions of the watershed is a limiting factor for a health biological community. For example, the following pictures show the reason conditions are poor at the Rt. 722 site. There are no natural riparian buffers and cattle have access to the stream. This has led to severe bank erosion, and mud and sand banks in the stream channel.

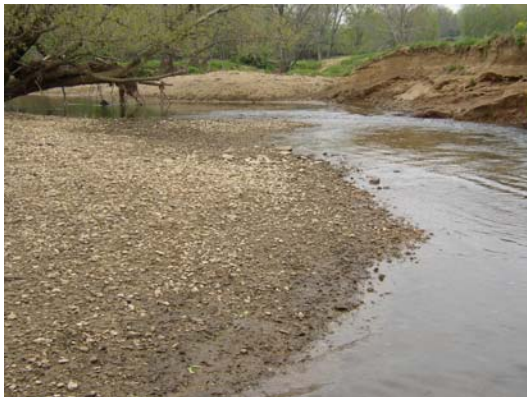
Severe bank erosion and mud bars at the Rt. 722 monitoring site along NF Goose Creek.

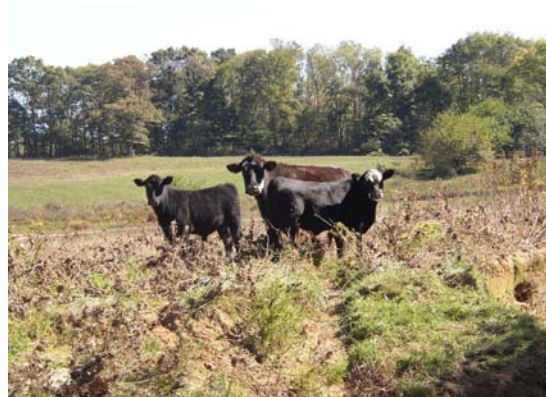
Cattle with stream access destroy riparian buffers and contribute to stream bank erosion.

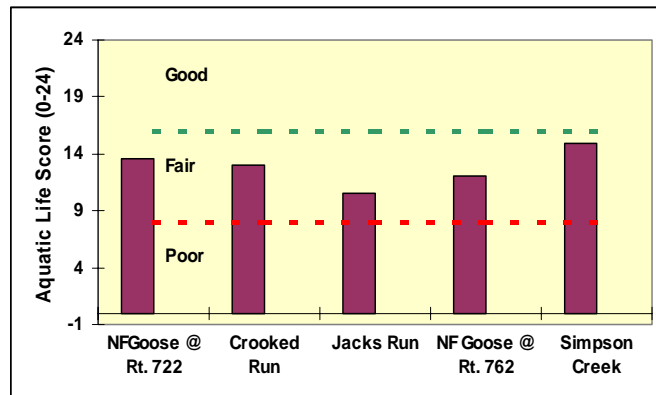
Figure 5. LWC Benthic Macroinvertebrate Scores for North Fork Goose Creek Watershed – 2004.

Loudoun Wildlife Conservancy – LWC has collected aquatic insect samples in North Fork Goose Creek and Crooked Run since 1997. These data were analyzed using EPA metrics, and the results are shown in **Figure 5**. The condition of the aquatic insect community at the North Fork monitoring site is in the “fair” range. This means that the

composition and diversity of the aquatic insect community is generally lower than what is expected if the stream was not being degraded. Many of the insects found are moderately tolerant of pollution. For example, the Netspinner Caddisfly (Hydropsychidae) was the most common insect found at the Rt. 762 site below Sleeter Lake. At the Crooked Run site, fewer than 50 insects were found in the spring sample and less than 100 in the fall sample. Over 200 insects per sample are common at good sites.

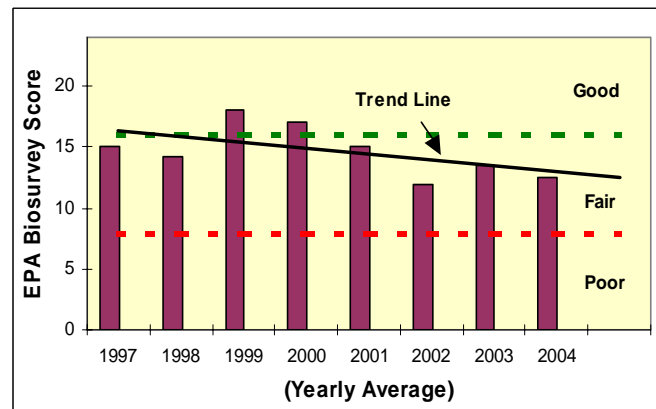
Figure 6. LWC Benthic Macroinvertebrate Scores for Crooked Run With Trend Line – 1997 – 2004.

The Crooked Run site data are also an example of the degrading trend that is occurring in portions of the watershed. **Figure 6** shows the downward trend of aquatic insects scores at the site over the last five years. Stream habitat conditions are characterized by increasing bank erosion, deposits of sediment in the stream bed, and poor substrate for aquatic insects (which accounts for the low numbers of insects).
