LIMESTONE BRANCH WATERSHED

2005 PROFILE

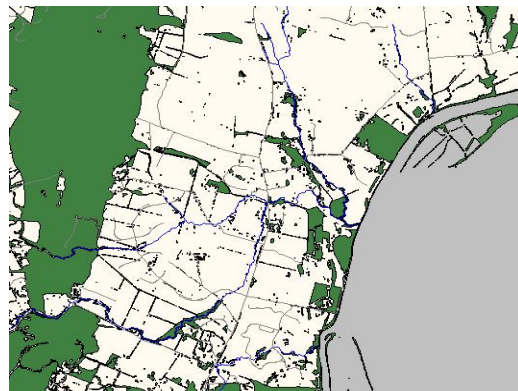
Limestone Branch watershed showing forest cover.

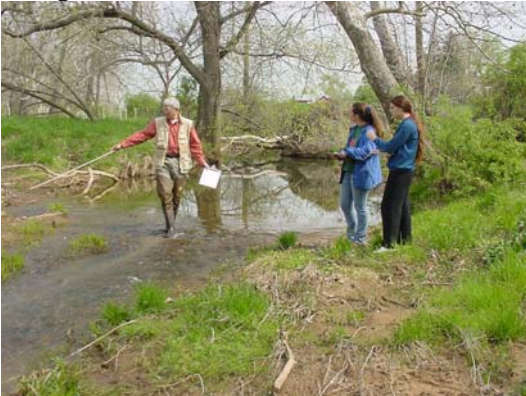
Figure 6. Aquatic Life Conditions in Unnamed Tributary to Limestone Branch at Rt. 661, 1997-2004.

Aquatic life conditions in the other tributary at the Rt. 661 station where there is no large development and golf course in the headwaters are different as seen in **Figure 6**. The conditions are generally in the “fair” to “good” range that means there are greater species diversity, more insects intolerant to pollution and sediments, and fewer that are pollution tolerant. Conditions also seem to be improving as shown by the trendline. This monitoring site is downstream of a regional park, and park authorities have fenced off the stream from livestock, planted trees, and allowed the natural vegetation to grow in the riparian buffer. This is greatly improving the stream habitat and stream conditions upstream of the monitoring site, and it may account for the improving aquatic life conditions at the downstream site.
